The $\frac{1}{4}$ corner of $\frac{33}{4}$ T7N R1W
 was FND Laying Next To the hole
 IT WAS PLACED IN. I replaced
 The conc. & Brass INTO The original
 hole and made A Tie from my
 Traverse To IT. D. Butters

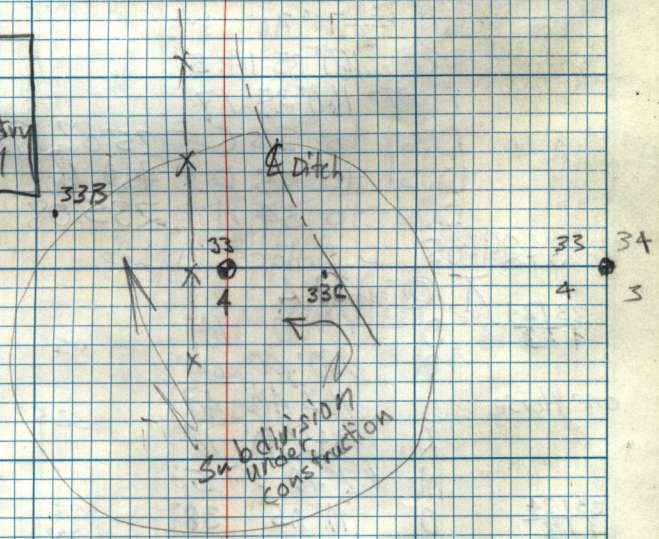
(The concrete was sheared in half)
 & probably by construction. This area
 is STAKED for a subdivision

T @ 33C B.S. $\frac{33}{4} | \frac{34}{3}$

RT To Replaced Sect. Brass
 $\frac{33}{4} = 152^{\circ} 19' 40''$

Dist. = 77.43
