Sidewalk-Notes for Repairs.

Made by J.M. Lentz - Beginning Feb. 24-1904.

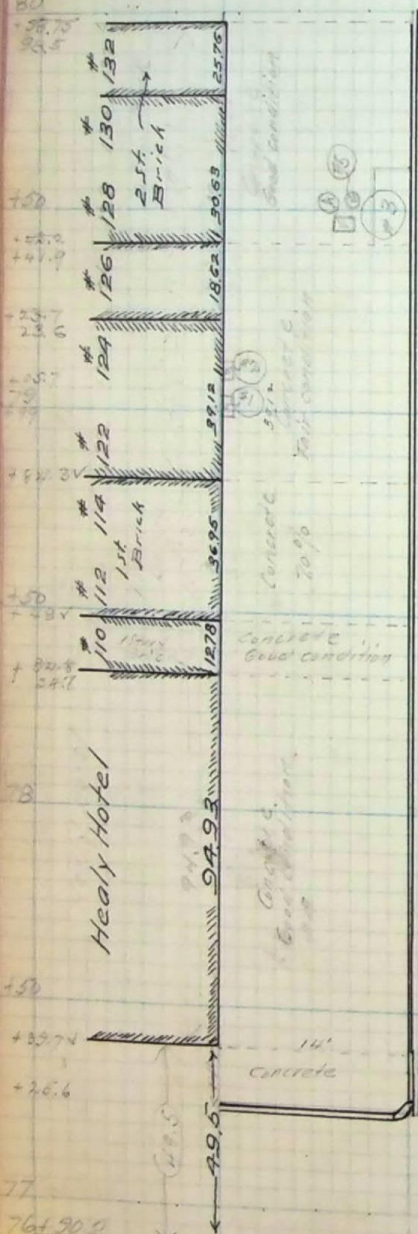
- #1 = 78+01 W. end of Basement Ventilator 2.0 Wide 3.2 Long
- #2 = 78+21.5 " " " " " " " 2.0 " 3.2 "
- #3 = 78+47. " " " " " " " 2.0 " 3.2 "
- #4 = 78+79.5 " " " " " " " 1.3 " 2.4 "
- #5 = 78+60.3 " " " " " " " 1.3 " 2.4 "
- #6 = 78+71.5 " " " " " " " 2.0 " 3.2 "
- #7 = 78+84.4 " " " " " " " 2.0 " 3.2 "
- #8 = 78+64.9 1 side " Small Alley bet. Buildings 3.6 Wide
- #9 = 78+73. " " " Basement trap doors iron 3.5" wide 5.0 Long 1.5 from curb
- #10 = 78+84.7 Ctr of M.H. 2.0 dia 1.5 from curb
- #11 = 78+92.8 " " " " " " " " " " " " " " " "
- #12 = 78+99 W. side of Basement trap doors iron 3.5" wide 5.0 Long 1.5 from curb

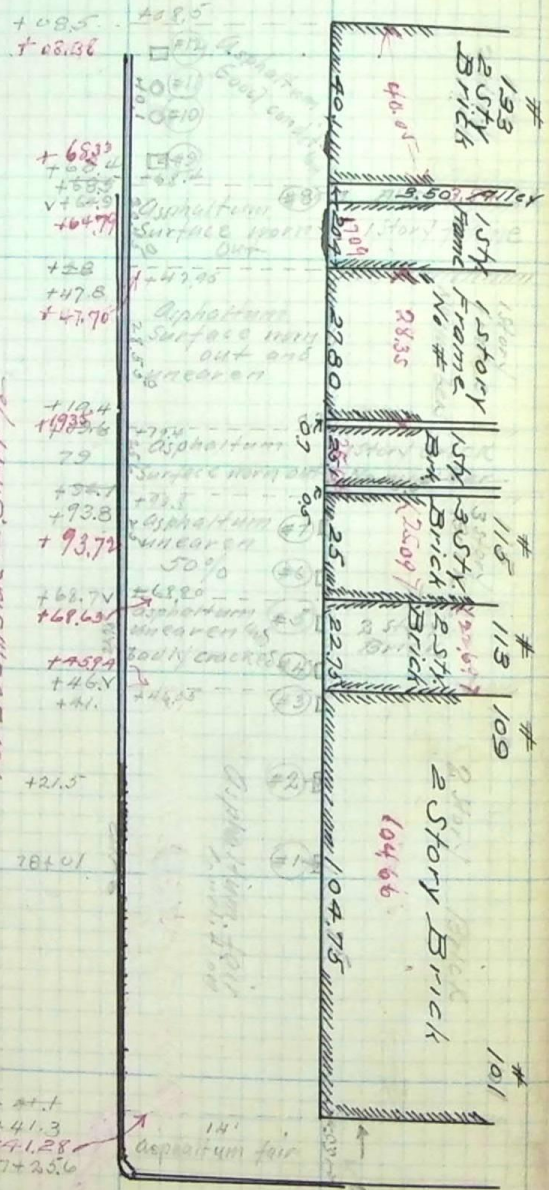
- #1 = 78+39 W. end of Basement Ventilator 1.6 Wide 2.9 Long
- #2 = 78+05.7 " " " " " " " 1.6 " 2.9 "
- #3 = 78+42.2 " " " Strip of concrete next to curb 2.25 wide 16.3 Long should be replaced
- #4 = 78+44.3 W. " " iron trap doors to basement 4.0 wide 5.0 Long
- #5 = 78+53 Center of M.H. 2' Dia.
