NARRATIVE

This survey was requested by Mrs. Laura Warburton in order to establish the Property Corners. Brass Cap monuments were found at the Northwest Corner and the West 1/4 Corner of Section 6, T6N, R2E, SLB&M. A line bearing N 0°16'36" E Between those two Monuments was used as the Basis of Bearings. Property Corners were monumented as depicted in this drawing.

Property Survey		Warburton Property All of Lot 3, Middle Fork Ranches, Weber County And a part of Section 6, T6N, R2E, SLB&M, U.S. Survey Weber County, Utah	
GREAT BASIN ENGINEERING NORTH <small>CONSULTING ENGINEERS AND SURVEYORS</small> 5746 South 1475 East - Suite 200 Ogden, Utah 84403 P.O. Box 150049, Ogden, Utah 84415 <small>Ogden (801)384-4515 Salt Lake City (801)321-0222 Fax (801)382-7544</small>	SCALE : 1"=50'	DATE : 2 Sep, 2009	DRWG. NO.
	DRAWN : DH	REVISIONS :	09N732
09N732-PS

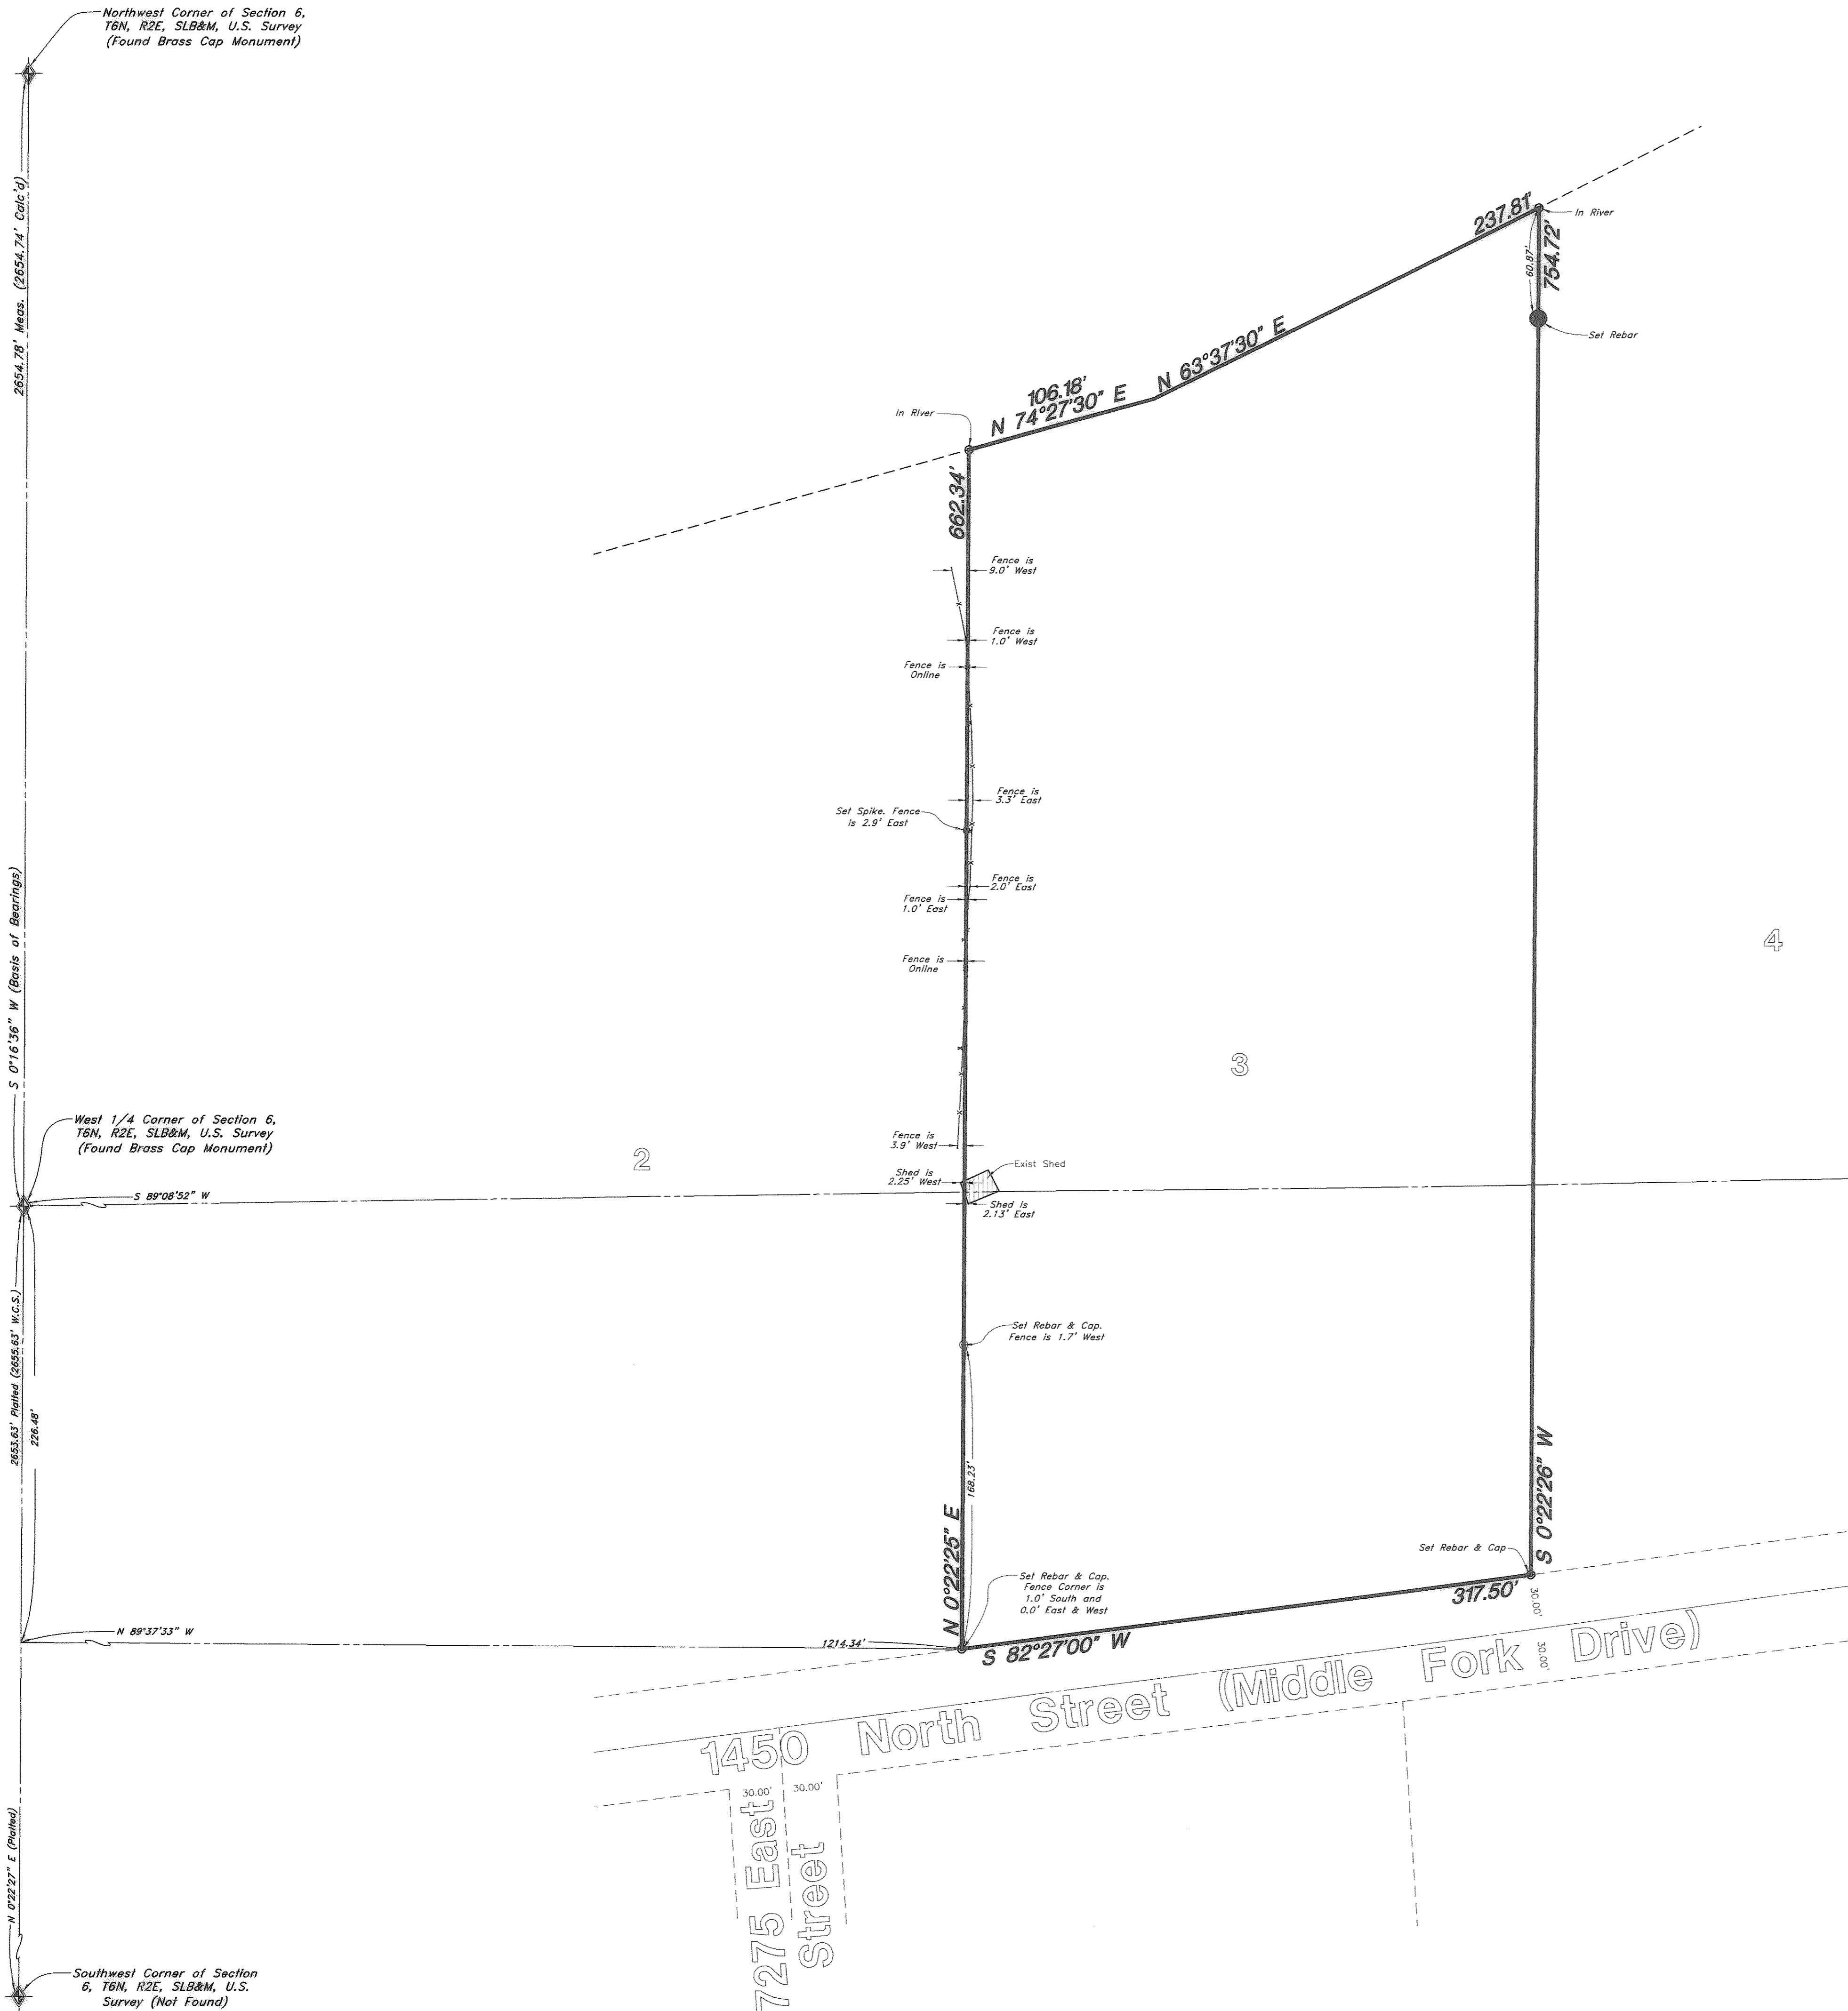
All of Lot 3 of Middle Fork Ranches, according to the Official Plat thereof, on record in the Weber County Surveyor's Office.
