## **Surveyors Narrative**

- A. This survey was requested by Glade McCombs to retrace their property boundaries in aid of achieving a new building permit. The project benchmark for this survey is 4910.00' assumed at the North quarter corner of said Section 19.

Reviewed by:THarper
February 2025
25009

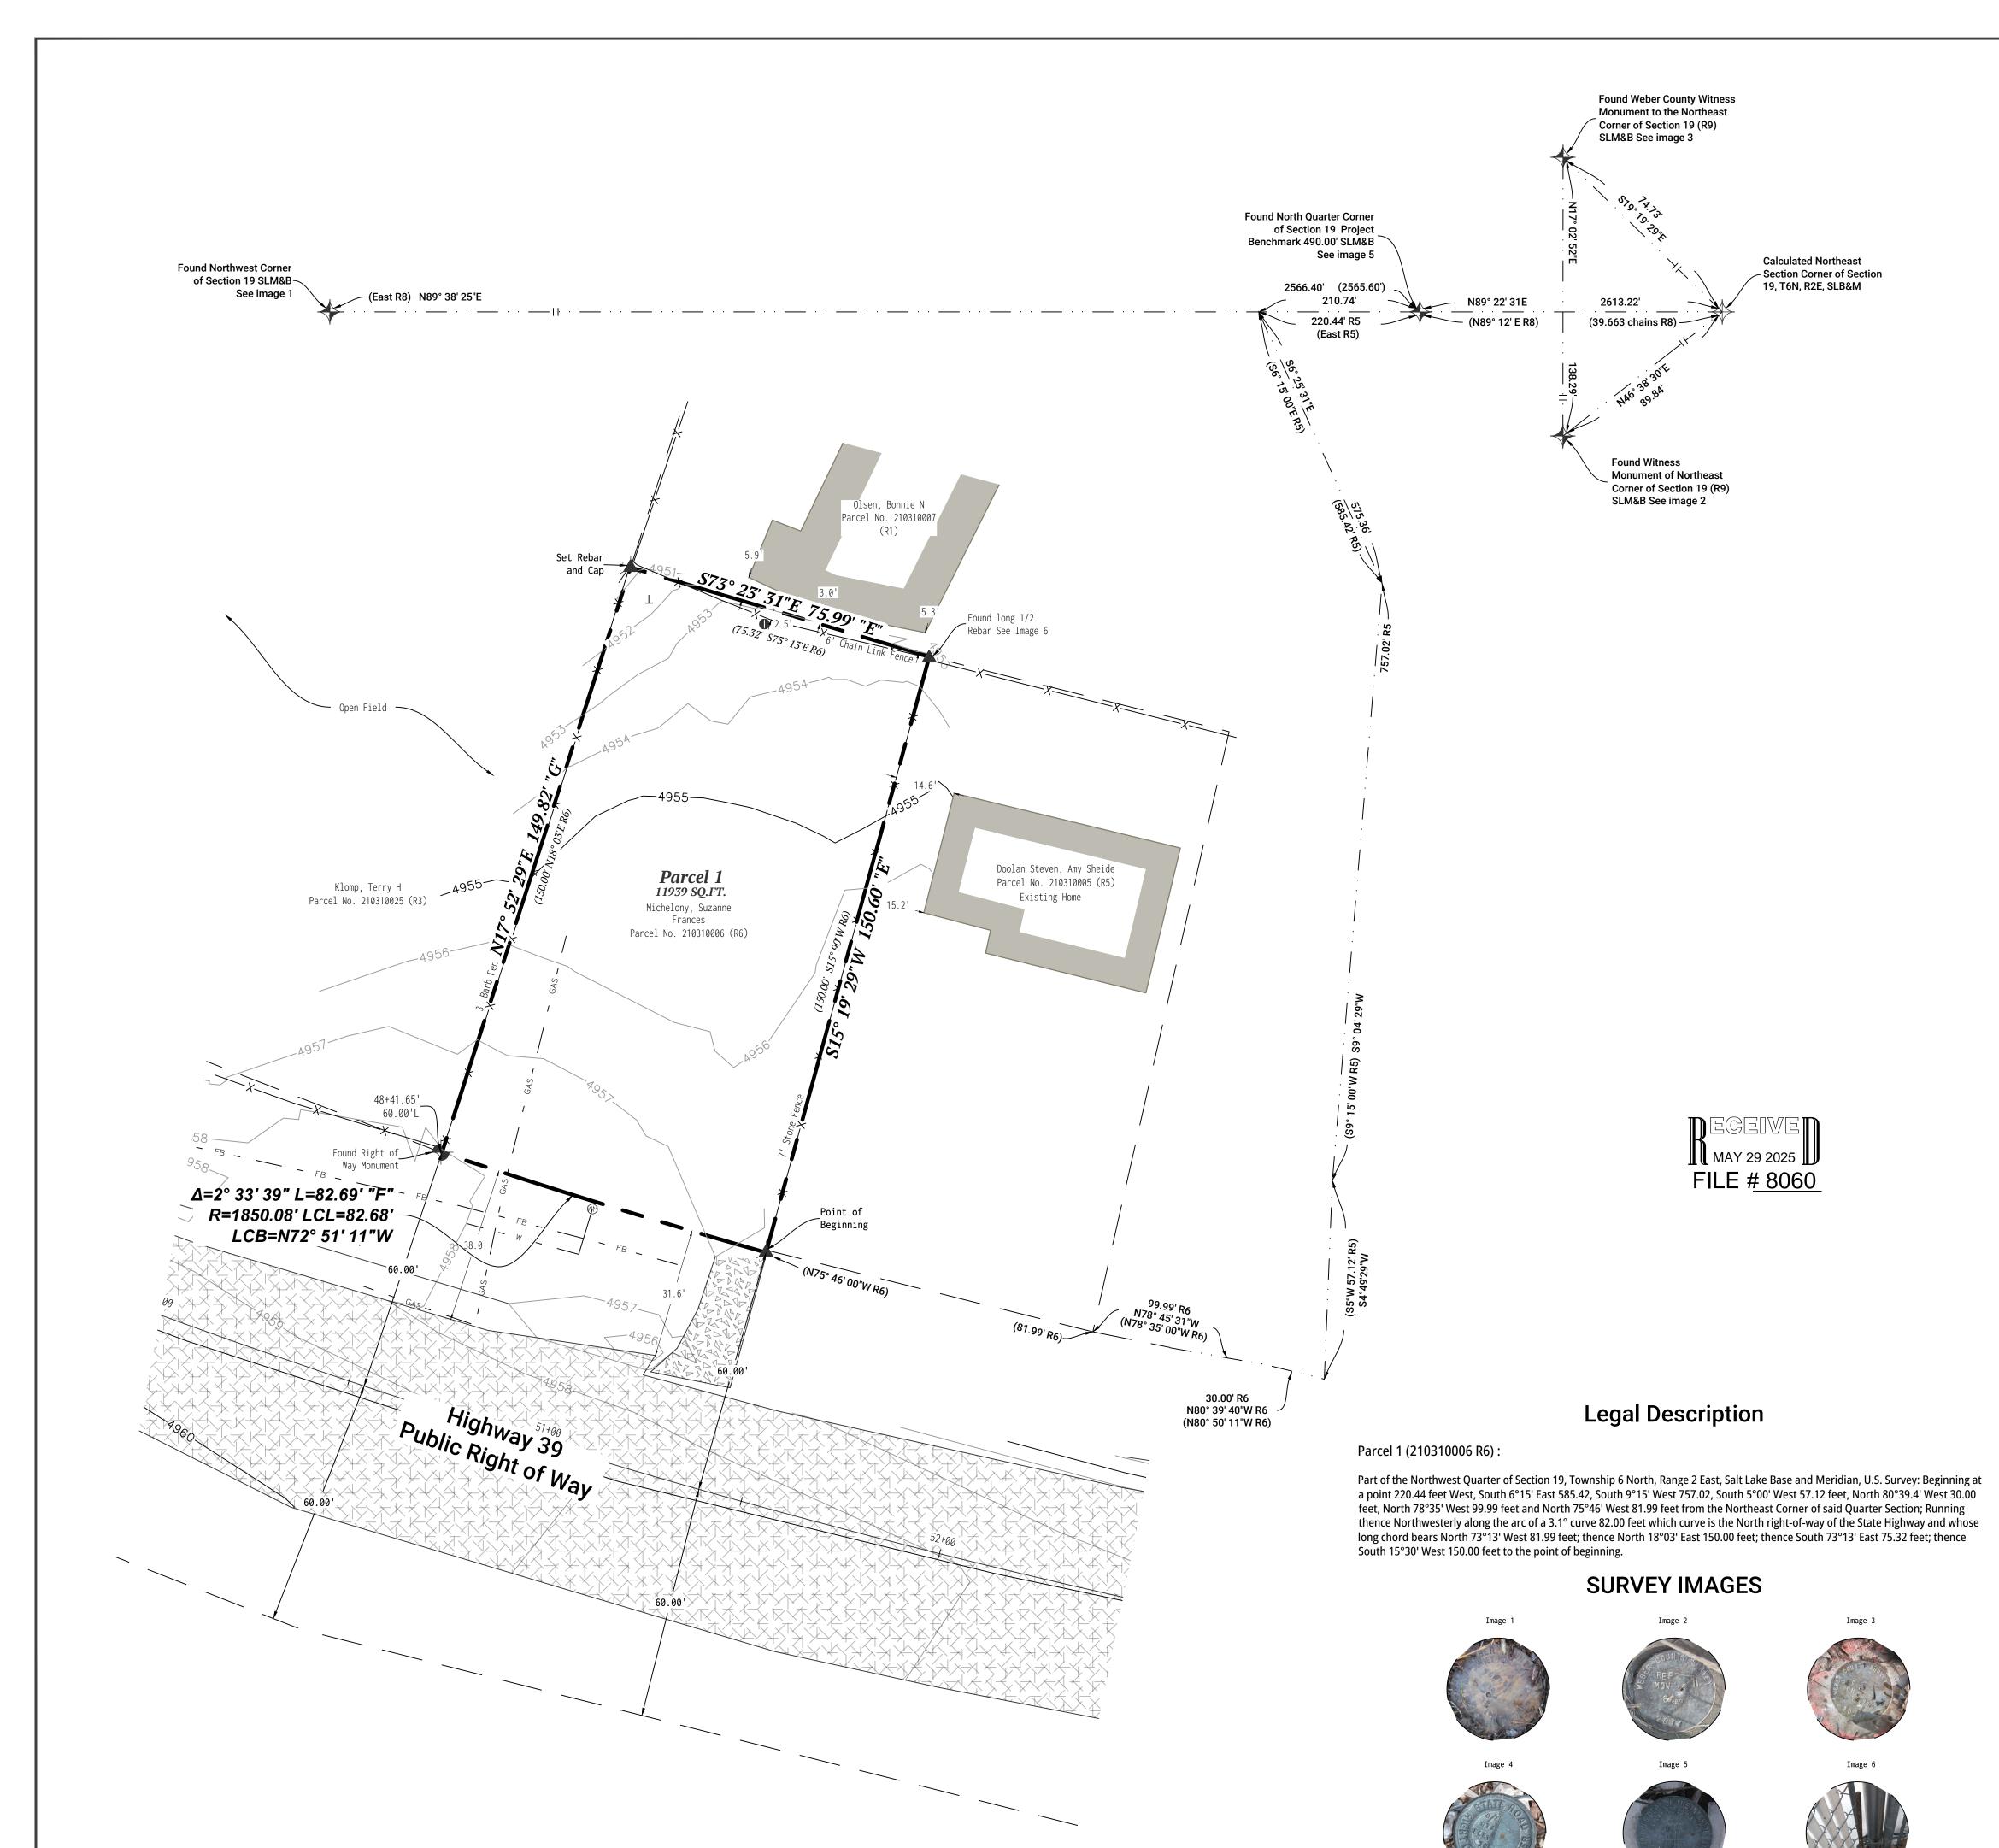
- B. The basis of bearing for this survey is Utah State Plane Grid North. Measurements between the North Quarter corner of Section 19 and the found northwest corner of Section 19 were recorded at a bearing of N 89°38'25" East. This basis of bearing was chosen due to no clear connection between the deed and the presently monumented Section Line.

- C. The retracement of the parcel began with retracing (R14) to the best of the ability of the surveyor, given the facts present. This retracement was necessary due to the record deeds surrounding the area referring to the old Territory Rd. The rotation of the deeds was determined from (R7), rotating the record bearing between the north quarter corner of section 19 and the northeast calculated quarter of section 19, and rotating said deeds to what would have been east along the northwest section line. This rotation matched the occupation and was held as the most probable rotation of the original deeds. However, the distance measurements from the presently monumented north quarter corner of said section 19 do not align with the current occupation of the road or the deeds. For this reason the Surveyor used a similar position as that shown by Ernest D. Rowley, North of the presently monumented North Quarter corner of Section 19. Rather than showing a theoretical position of said townsite plot location, the Surveyor has maintained the relationship by showing record and measured values along the presently monumented lines.

- D. Furthermore the surveyor has also retraced U maps our 11 are 12 and R13AS provided by U dot. The surveyor's findings are that the presently monumented right away marker intended to be at the point of curvature According to set plans and the ark location versus the actual location of the road do not agree for this reason the surveyor believes that there is a measured value along said arc holding the radius as true and shortening the delta and the length. Placement of the right away in this manner agree with the other survey work that have been done and the true position of the right of way as occupied the surveyor does note however that the curve data contained within the deed and the curve data of said right away maps do not agree. Despite the discrepancy the surveyor has held the right away maps.

- E. With R14 retraced as explained, the surveyor confirmed the deed locations matched and agreed with the current fence line. The surveyor also must note that they may have been other survey work that was not of record that had led to the creation of the 7 feet stone fence as noted in P16.

- F. Holding the Right of Way as retracted, explained in section "D," each other along the right-of-way as retraced.
- G. A small gap of just over half a foot was discovered between R6 and R3 due to different calls along Territorial Road. The Surveyor held the position of R3 because it aligned with the historic fence line, which is likely where the grantors intended to convey matches with he right of way monument and the fence line follows the radial bearing of the Right of Way arc.

- H. Property corners were marked as shown here and referenced in the survey research and analysis. If any data contrary to the surveyor's opinion is found, it should be presented for consideration.
