NARRATIVE

This survey was requested by Mr. Rich Sirken of Weber State University for the purpose of determining the location of the South line of the subject parcel as it related to the North Line of the Adjoining subdivisions and the existing occupation and the North line of the subject parcel.

Record of Survey
WSU Strongs Peak
 Approximately 4000 S. Skyline Drive

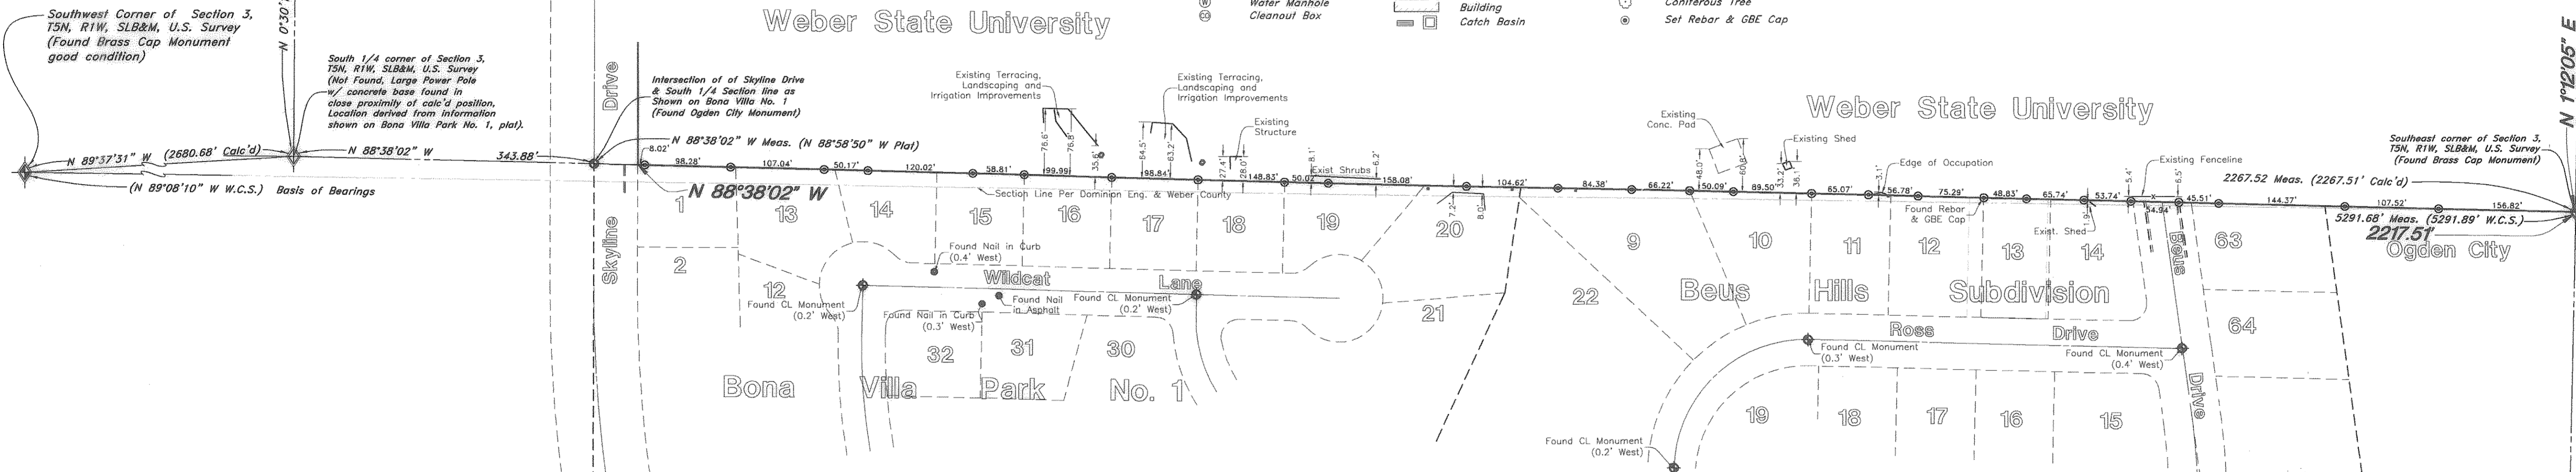
Weber County Brass Cap Monuments were found at the Southeast corner, the Southwest corner, the North 1/4 corner and the East 1/4 corner of Section 3, T5N, R1W, SLB&M, U.S. Survey. A Witness Corner to the East 1/4 corner corner was also found.

An Ogden City Monument was found at the Intersection of Skyline Drive the South line of said Section 3, as shown on the Bona Villa Park No. 1, College Heights Subdivision, and the Ogden City Engineering Plats (2717-A). The location of the South 1/4 corner has under gone construction activities of a power sub station and a large metal power pole with a large concrete base. The Location of the South 1/4 corner of the Section was determined using these plats and the Ogden City Monument.
