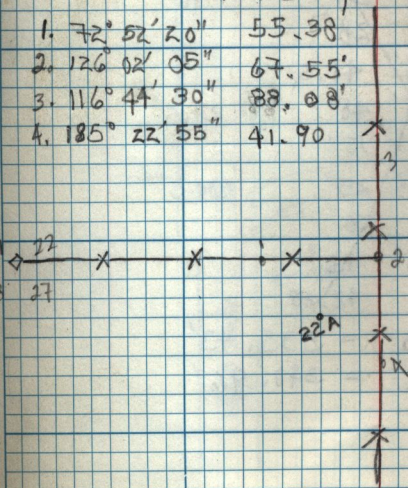
Brass Cap
2" Alum Pipe

Located in
Clump of Scrub oak
on 35° slope

Post 4x4"
8' NW
of Brasscap

- 1. 72° 52' 20" 55.38'
- 2. 126° 02' 05" 67.55'
- 3. 116° 44' 30" 88.08'
- 4. 185° 22' 55" 41.90'
