SOUTH SIDE 25th ST.

NORTH SIDE 25th ST.

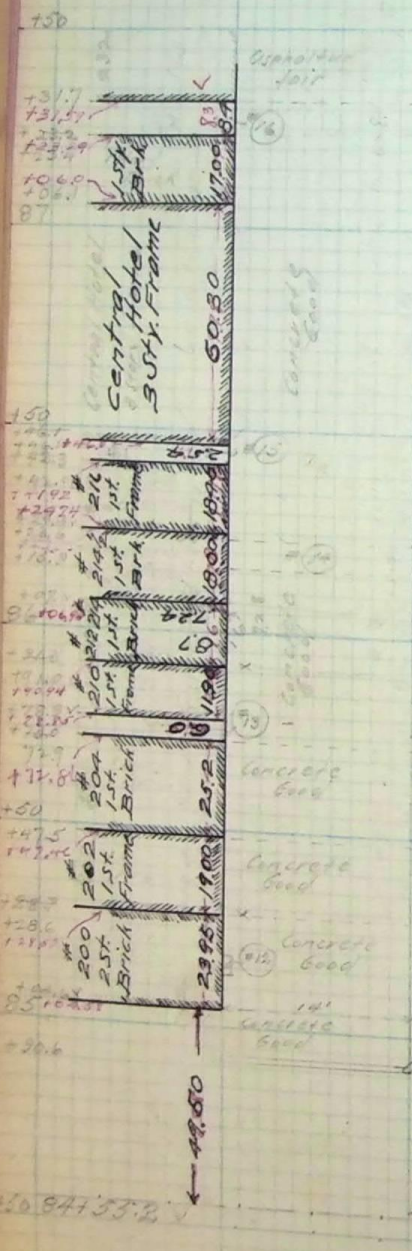
all figures except black are void
 figures in red = correction for
 error in tape = 0.417 of
 1/24 North side

- #1 = 85+20.2 W Side of iron trap doors to basement 3' wide 4.0 long 4.3 from curb
- #2 = 85+27.0 " " " " " " " " 3.0 " 4.0 " 4.3 " "
- #3 = 85+44.1 " " " " " " " " strip 2' wide across walk entirely gone
- #4 = 86+26 " end of basement vent later 1.8 wide 3.5 long
- #5 = 86+38.7 " " " " " " " " 2.0 " 4.0 "

- #12 = 85+73.4 W. End of basement ventilator 2.5 wide 9.3 long
- #13 = 85+78.9 " Side of 1st Brk frame "Today's" Shoe Shop No number
- #14 = 86+15.9 " " " " Concrete 7.7 wide 14' from curb to building should be removed
- #15 = 86+48.3 " " " " Fire wall and opening bet. Central Hotel 25 Building st.
- #16 = 87+23.2 " " " " " " " " " " External 8.7 wide seldom used as driveway
