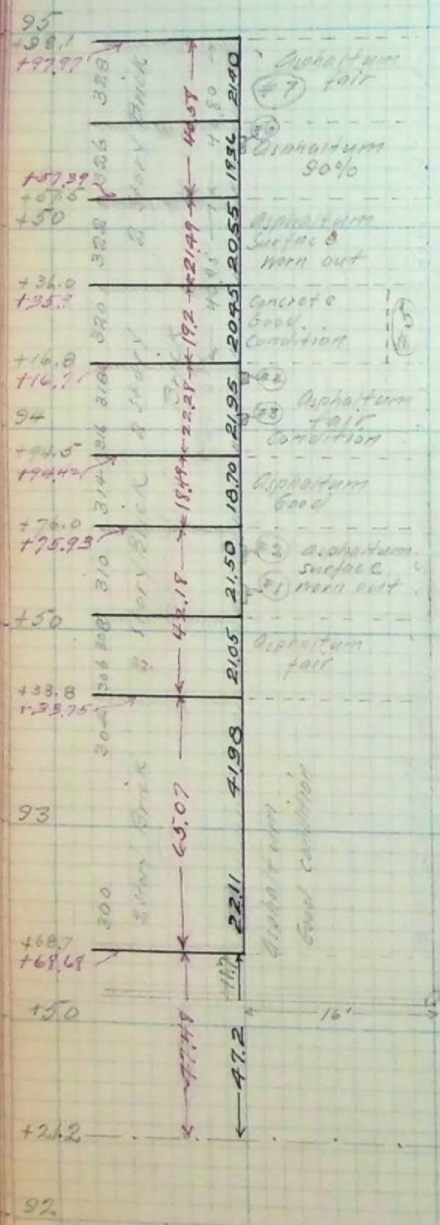
Figures in red - correction for error in tape  
 error = .048 % on North side  
 all figures except black & void  
 25th STREET

- #1 = 93+56.6 W. end of basement ventilator 2.5 wide 3.0 Long
- #2 = 93+67.4 " " " " " 2.5 " 3.0 "
- #3 = 94+00.8 " " " " " 2.0 " 3.0 "
- #4 = 94+10.6 " " " " " 2.0 " 3.0 "
- #5 = 94+16.8 " " " side walk +2 wide 19.2 Long about 6% along curb  
 2' below curb grade
- #6 = 94+69.8 " " " basement ventilator 2.3 wide 3.0 long
- #7 Note - This mark in fair condition with exception of 3 small holes about  
 1x1. 2 or 3 inches deep
