Property Survey

LaRocque Property
A part of the Northwest 1/4 of Section 22, T7N, R1E, SLB&M, U.S. Survey
Weber County, Utah

DRWG. NO.
08N725

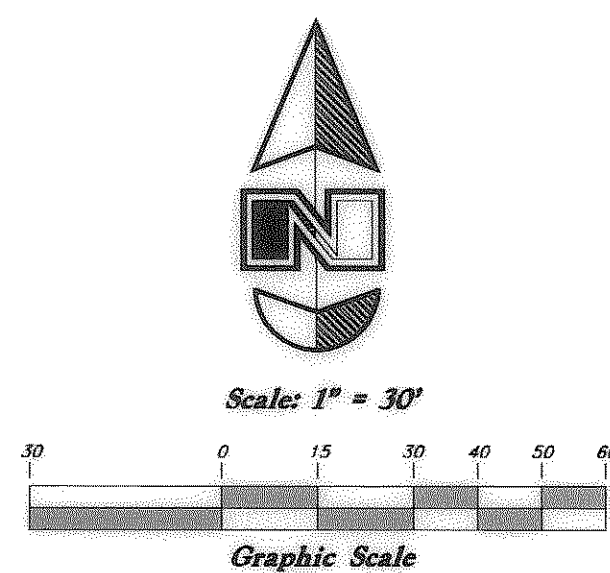
This survey was requested by Mrs. Beverly LaRocque for the purpose of reestablishing property corners. Brass Cap Monuments were found at the Southwest Corner and the Southeast Corner of the Northwest Quarter of Section 22, and the Southwest Corner of Section 22, T7N, R1E, SLB&M, U.S. Survey. A line bearing N 89°31'15" W between these two monuments was used as the Basis of Bearings. Property Corners were monumented as shown.

All of Lot 27, Wolf Creek Subdivision No. 2, on record in the Weber County Recorder's Office, Book 22, Page 19.

Southwest Corner of the Northwest 1/4 of Section 22, T7N, R1E, SLB&M, U.S. Survey (Found Brass Cap Monument)

Southeast Corner of the Northwest 1/4 of Section 22, T7N, R1E, SLB&M, U.S. Survey (Found Brass Cap Monument)
